OBJECT: "Current repair and artistic lighting of" Magurata "cave with rock paintings from the Bronze Age", Belogradchik municipality, Vidin district "

PART: ARCHITECTURE

PHASE: CURRENT REPAIR

EXPLANATORY NOTE

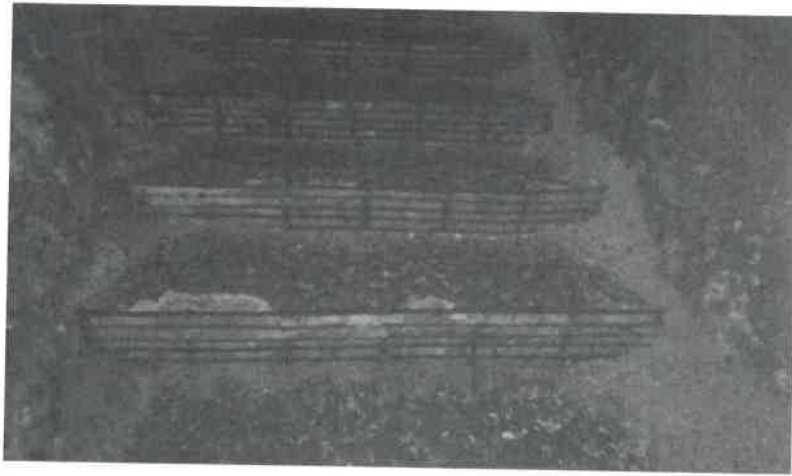
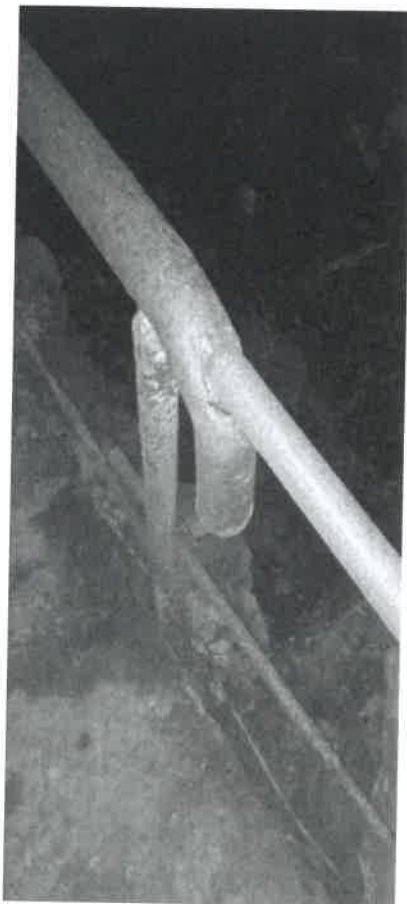
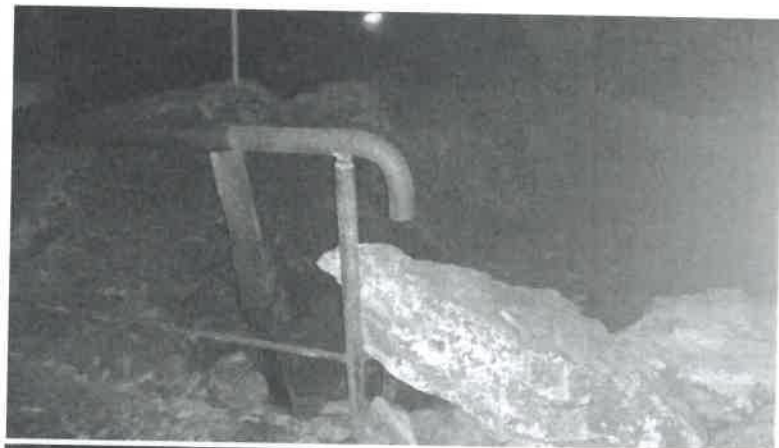
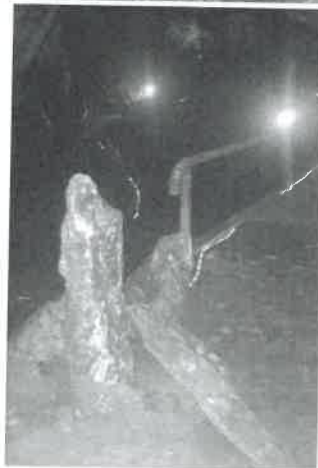
The public building solutions have been made in the cave since 1961. and need to improve their operational performance and ongoing repairs due to their compromised condition. Lighting is poor and in poor condition, a large number of lighting fixtures are not working and are not in the proper state, leading to a difficult passage on the tourist route. The metal rails have been rusted and need to be cleaned in some places - replacement with new ones, and some sections of the track are missing and new ones need to be added to ensure the safe passage of the groups of people along the track.

In the "Gallery with drawings" the steps are broken, the reinforcement that forms and maintains them is rusty and needs to be processed because of its compromised condition.

In order to improve the physical condition of the alleyway network and in order to safely pass the flow of tourists, the following activities are envisaged:

- Replacement of lighting fixtures is foreseen due to the large number of non-functioning ones, introducing modern energy-efficient light sources and lighting fixtures, according to the specific heavy conditions of work. Lighting will be "cold" sources (LEDs), and the power, focus, and operating mode of the spotlight should be consistent with the habitat of the bats.

- Cleaning and anti-corrosion treatment of existing railings, and new places will be added where necessary;
- Anticorrosive treatment and repair of the steps in the Gallery with drawings. Filling of the formed "pockets" with earth mass, extracted from the excavation works made during the drilling archeological studies;
- Replacement of the grille metal door, located at the entrance to the Gallery with the drawings due to its extremely poor amortized state. The holes need to be horizontal (at 20 cm) to ensure that the bats are unobstructed;
- The metal staircase, located in the "Oriental City" gallery at a height of 4,40 meters, is dampened due to rust and long-lasting use, resulting in the risk of accidents in the service of lighting fixtures;
- Restoration of damaged stone pavement where it is compromised (in case of previous installation of metal railings);
